Manhole Inspection Summary

Manhole # S19M__033MH

Insp Date: **3/25/08 12:56 PM**

Location Address: **511 bentalou-alley-smallwood** Cross Street: **ashton st**

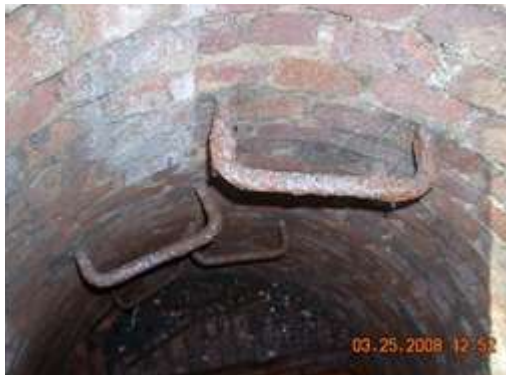
Defect 1

Steps Count: **4** Missing: **0** ☒ **Corroded**

corroded steps

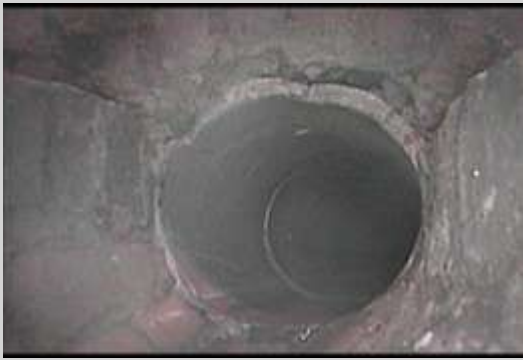
12 O'Clock Outflow

Pipe Height: **7.2** (in.) Rod and Bar (Angled)
Pipe Material: **Clay** ☐ Pipe Lined
Invert Depth: **9.00** (ft.) Flow Characteristics: **Slow**
Deposits: ☒ None ☐ Mud ☐ Sludge ☐ Debris ☐ Grease
Silt Depth: **0** (in.) Deposits Extent:
Infiltration: **None** Pipe Seal Cond: **Broken**

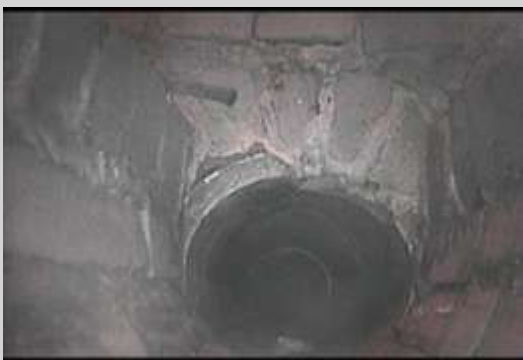
6 O'Clock Inflow

Pipe Height: **8.4** (in.) Rod and Bar (Angled)
Pipe Material: **Clay** ☐ Pipe Lined
Invert Depth: **8.92** (ft.) Flow Characteristics: **Slow**
Deposits: ☒ None ☐ Mud ☐ Sludge ☐ Debris ☐ Grease
Silt Depth: **0** (in.) Deposits Extent:
Infiltration: **None** Pipe Seal Cond: **Broken**

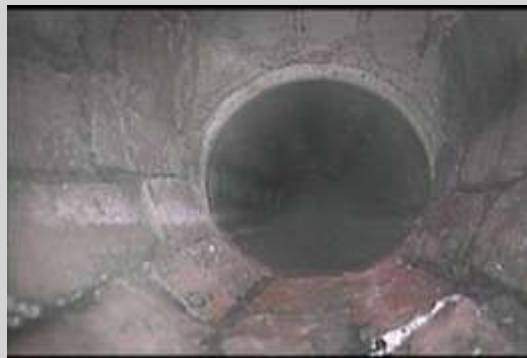
9 O'Clock Inflow

Infiltration: **None** Pipe Seal Cond: **Sound**
